Facilities Assessment

1800 Grand Ave. Laramie, WY 82070

Facilities Assessment
St. Paul's Newman Center
Laramie Wyoming

February 11, 2018

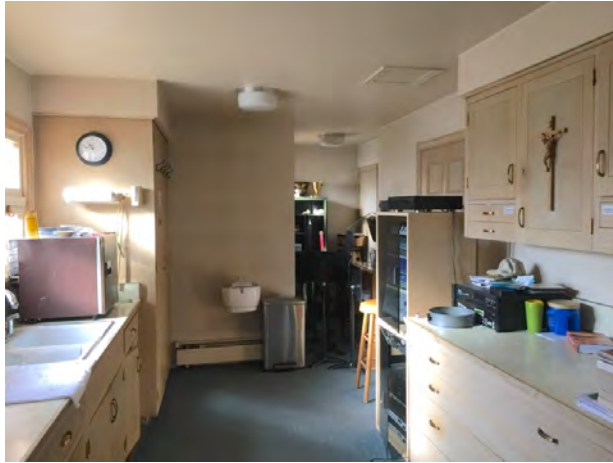
The existing sacristy is a good location for a working sacristy in its proximity to the sanctuary, but it is currently a traffic mess in the time

before mass, as the space is shared by servers, the priest, and musicians.

Current activities in the sacristy include vesting, musical instrument storage, vessels for mass, etc., and are simply too numerous and too chaotic for a space of only 106 SF.

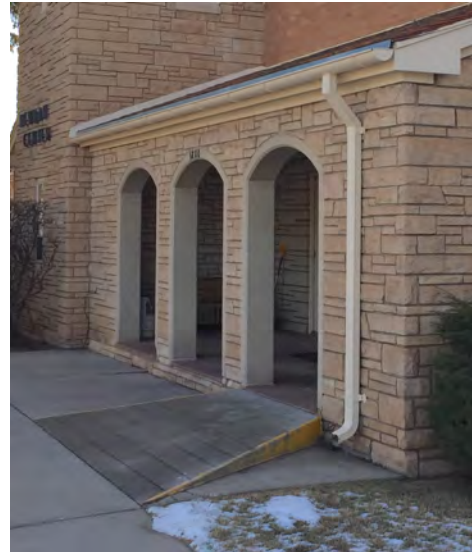
It is quite common for a building built in the 1950's to be inaccessible or at least quite challenging for people with disabilities. Every entry to the Newman Center has at least one step, but this has been corrected at the north main entry with a well-designed ramp at the west entry arch of the portico. However, because this main entry and its ramp is on the north side of the building next to a gutter downspout that drains onto the concrete walk, which in turn slopes back toward the building, the potential for ice formation and an accident is high. The upside is that the gutter itself is likely usually frozen, so only limited water may reach the walkway during freezing weather.

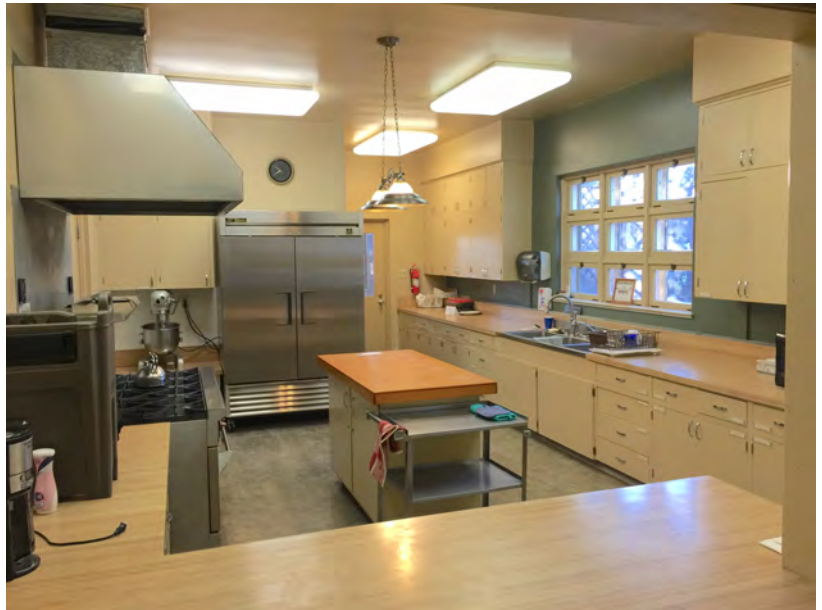
The basic problem of the kitchen as it is laid out and as it is used within the overall building is that it is a main entry for staff and even many parishioners, because it is the shortest route from the main (east) parking lot to the warmth of the building. The enclosure of the porch on the south east corner of the building a few years ago was a major improvement to the cold air entering the kitchen, and the porch also offers additional non-temperature-sensitive storage for the kitchen.

One of the more problematic areas of the kitchen is the narrow de facto hallway immediately in front of the commercial mixer next to the refrigerator/freezer unit. The conflict between people walking by and the person using the mixer creates potential danger for the person using the mixer. Also, though not particularly dangerous, the passageway from the porch door to the door to Bishop Newell Hall (BNH) makes work interruptions likely for people working at the kitchen counter along the south wall of the kitchen. As the primary food prep space in the kitchen, this is not a desirable situation.

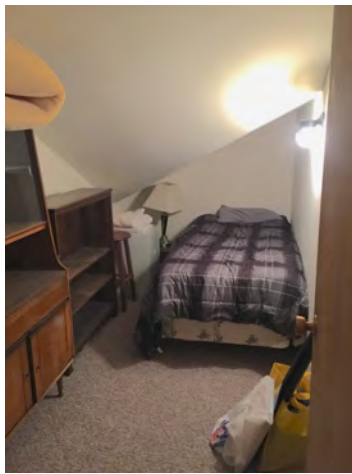
On the second floor, above the Library and a portion of the Fireplace Room, is an apartment with two rooms used as bedrooms, but neither is up to safety standards for exiting,

or in fact for even calling them bedrooms. The larger of the two rooms could be upgraded by enlarging and repositioning the existing window, but the smaller is wholly inadequate due to the lack of headroom and any window at all. Fortunately, the smaller room does not appear to normally be used.

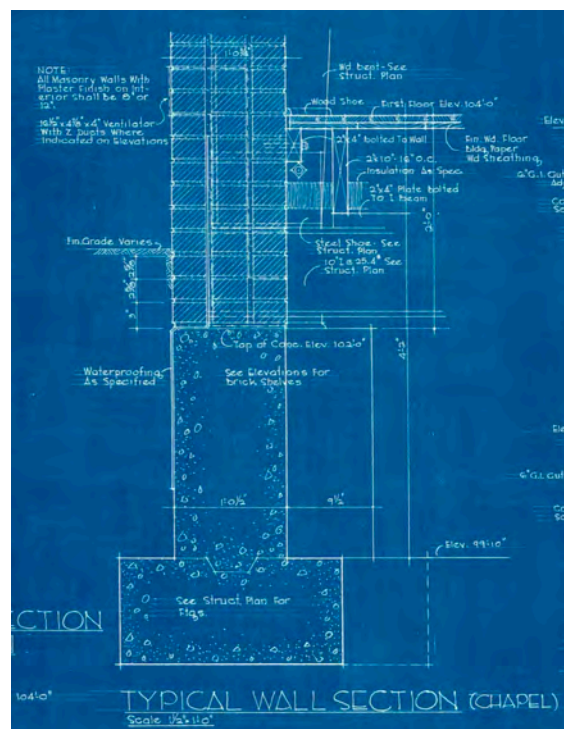
This construction method, common in the 1950's, yielded a massive wall "built to last." In later years, however, the lack of any insulating airspace whatsoever, becomes a liability because of the low R-value of brick. Assuming two wythes of "face" brick, and one wythe of "common" brick (between the outer two layers), the R-value of these exterior walls is approximately R 1.7 because of the lack of internal air space and no place for any air-entrapping insulation. The R-value of the 12" thick concrete beams over the larger openings in exterior walls is similarly low at approximately R 2.0.

It is feasible to add insulation on the inside of the brick walls by furring them out with, say, 2x2 wood furring strips, then applying spray foam between the strips, and covering it all with standard 5/8" gypsum board. There is no accommodation for electrical or IT wiring within the solid brick walls, so some could be added within the furring strips. This would make the walls about an R 12, which is not up to current standards, but would clearly be a major improvement.

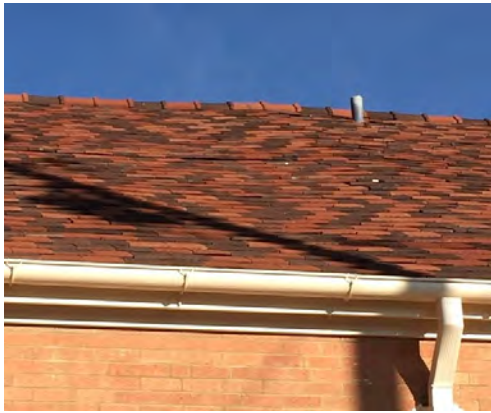
The roof over both south and north sides of the east end of the building shows dips (low areas) at regular intervals likely between the roof trusses. Internal inspection of the trusses shows no damage or sagging, so it likely that the dips in the roof tile are the result of sagging of the 1x 8 wood sheathing, perhaps because those particular boards were weaker than the others or possibly spliced in a single line creating a weak plane.

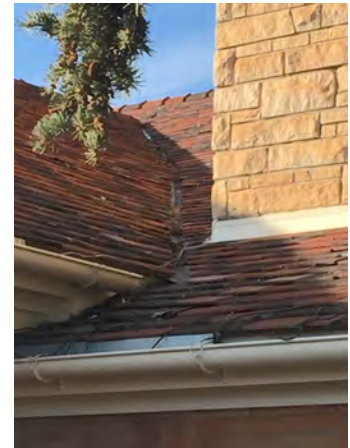
The roof valley immediately to the south of the Belfry's south wall has an unexplained curve to it that suggests some framing problems with the original roof. The curve is more likely to accumulate leaves and other debris that could cause water or ice backups that could lead to leaks,

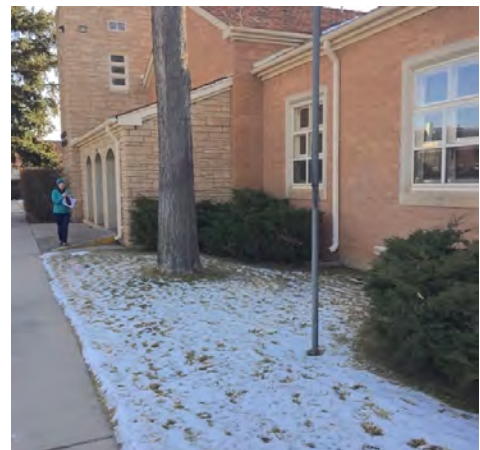
It is a testament to the quality of the soil underneath the footings of the Newman Center that there has been almost no foundation settlement, because water draining from the roof is collected by the roof gutters and directed via downspouts to within a few inches of the foundation wall. In locations where the ground around the building slopes away from the building, this water has the chance to flow away from the building, but in many situations, such as along much of the north building wall facing Grand Ave., the ground actually slopes *toward* the building, exacerbating the potential for the water to cause problems for the foundation. However, the foundation evidences extremely little movement after decades of this condition, and the crawl space is as dry as could ever be desired.

If the all or part of the building were to be retained, it would still be desirable to make the relatively simple adjustments to the ground around the building and to the downspout system to move the water away from the building.

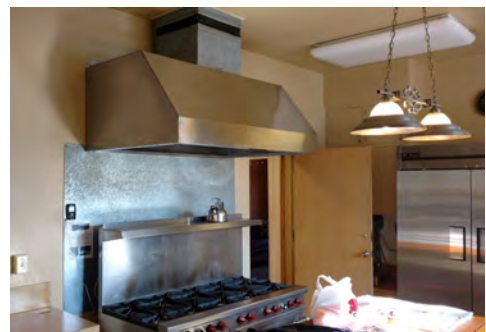
The kitchen has a stainless-steel hood located above the 10-burner gas range/oven. The hood is a Type II hood and does not have grease filters or a fire suppression system. The hood exhaust duct is connected to a utility type exhaust fan

located in the attic which is then exhausted outdoors through a sidewall louver. Code does not allow a Type II Hood over a 10-burner gas range.

The plumbing for the kitchen should be replaced with a commercial kitchen design approach using plumbing fixtures that to current health and food safety standards would be required. This would include but be limited to stainless steel, NSF 61 certified fixtures which would include 3-compartment sinks, prep sinks, and hand sinks. The 3-compartment sink and prep sinks would be required to be indirectly connected to the plumbing sewer system through sanitary floor sinks. A new grease interceptor would be required to capture any grease waste from the kitchen. Typical installations use a 1,000-gallon concrete precast grease interceptor installed outdoors. Newer alternative outdoor hydro-mechanical grease interceptors made of high density polyethylene should be evaluated as they require a smaller footprint and have better corrosion resistance than concrete.

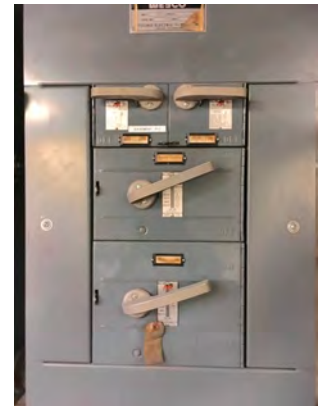
Except for Panel P-1 and Panel F, the service and distribution panels are dated, and should be replaced. The service to the building should be upgraded to a 3-phase service if air conditioning is ever considered for the building.

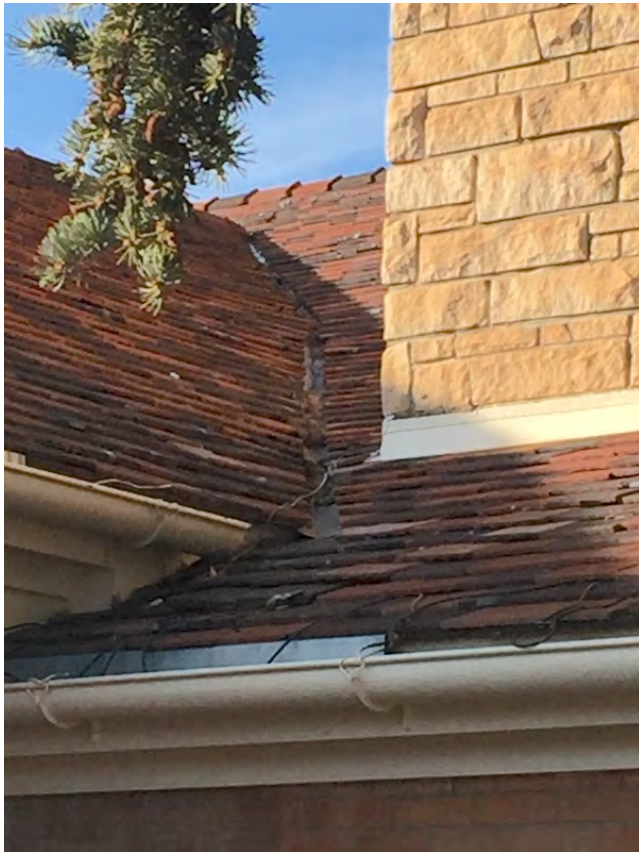
Irregular valley at south side of Belfry

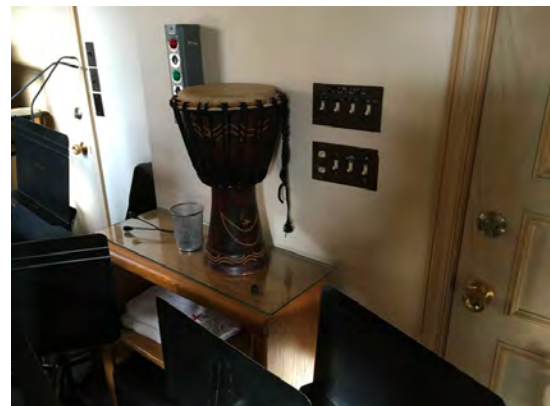
Controls do not meet the current energy code standards
