Facilities Assessment

1800 Grand Ave. Laramie, WY 82070

Facilities Assessment
St. Paul's Newman Center
Laramie Wyoming

February 11, 2018

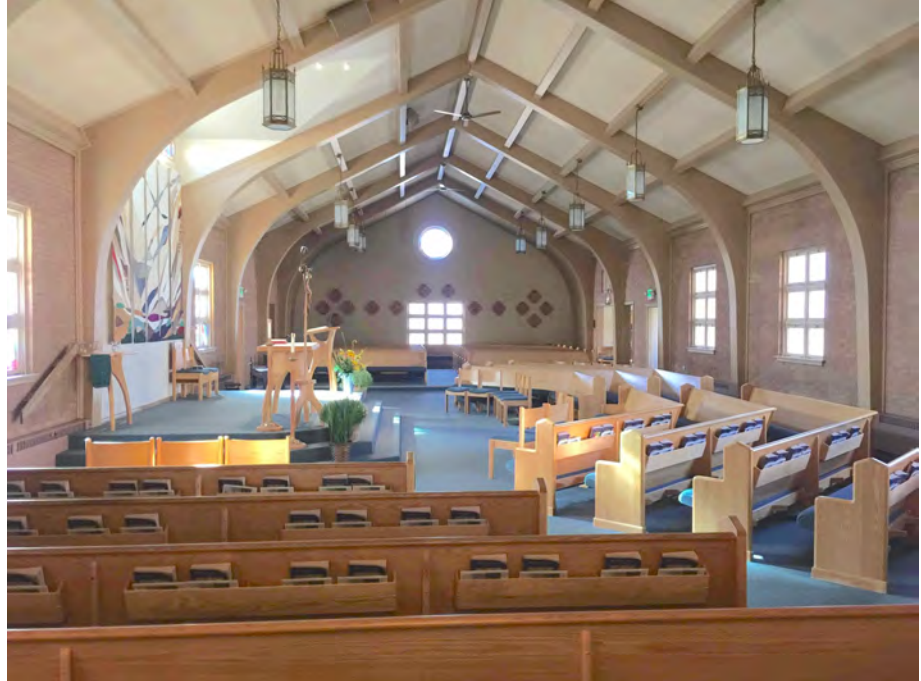
In 1995 the Nave underwent a major change of orientation from long and narrow with the Sanctuary at the west end of the space, to short and wide with the Sanctuary centered on the south wall of the space. The purpose and effect of this change was to allow for a closer visual/ emotional connection of members of the congregation to the activities of the Sanctuary. To emphasize the change of direction and to help create a new focus for the congregation, a dormer and stained-glass window was added above the sanctuary.

With the large increase in attendance at SPNC, the Nave has become too crowded and the width of the reconfigured space is not ideal for engaging parishioners using either the west end seating or the overflow seating in the “fireplace room” to the east. Processional entry to the Nave is complicated by the circuitous path created by the pew layout

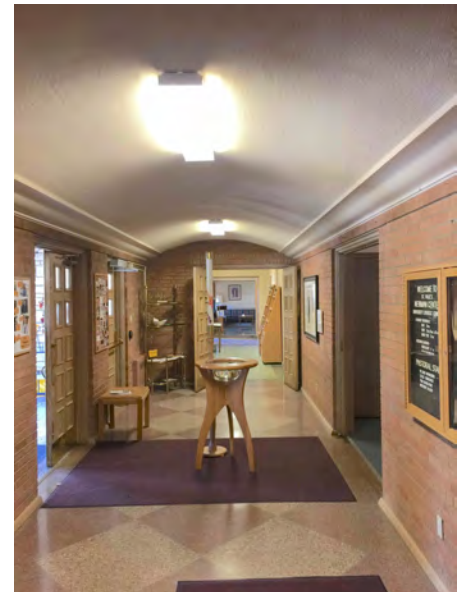
The Narthex features a gently curving ceiling that gives a distinctive and comfortable appearance appropriate for a welcoming area. Finishes are nicely refined, with brick walls, plaster walls, and a decorative terrazzo floor. However, this Narthex is seriously undersized, creating a bottleneck for the number of people needing to use it for both ingress/ egress and greeting/ visiting before and after services. It is important for this community-enhancing activity to take place, so the size of the Narthex is a serious problem.

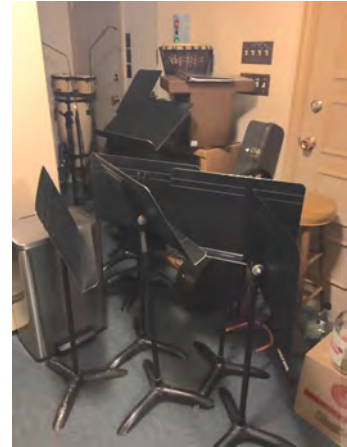
The existing sacristy is a good location for a working sacristy in its proximity to the sanctuary, but it is currently a traffic mess in the time

before mass, as the space is shared by servers, the priest, and musicians.

Current activities in the sacristy include vesting, musical instrument storage, vessels for mass, etc., and are simply too numerous and too chaotic for a space of only 106 SF.

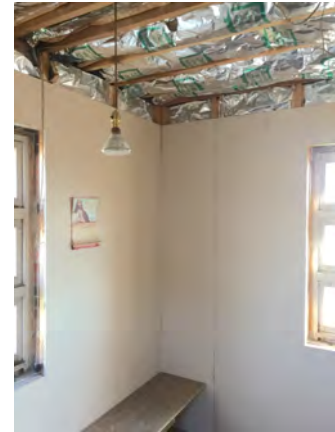
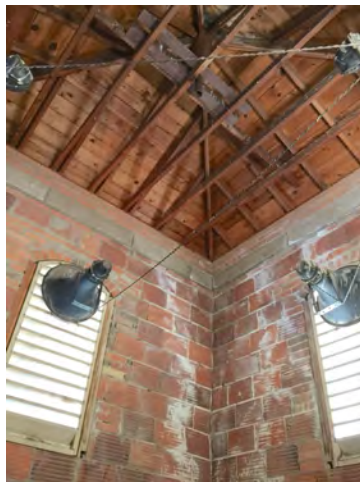
The middle room is partially finished with gypsum board on the wood-furred walls, a rough floor of wood sheathing, exposed foil-faced insulation, and no trim around the single windows located on each of the west, north, and east walls. The room is unheated and unused. The wall calendar is open to September 1971.

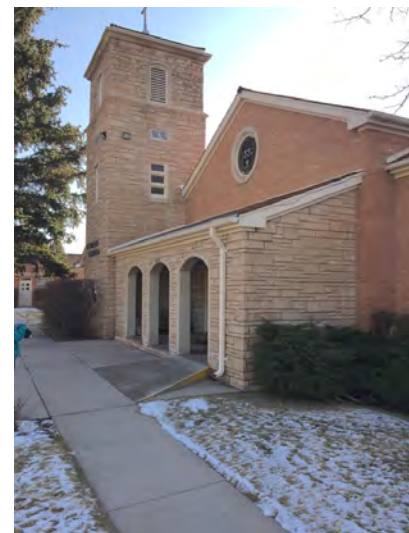
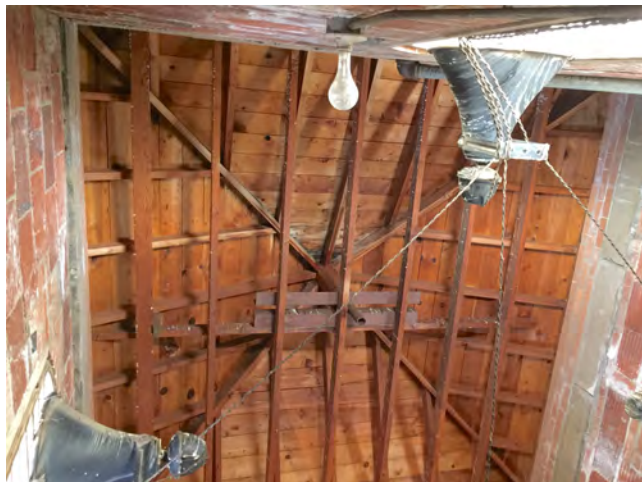
The top room in the Belfry has exposed structural clay tile interior walls faced on the outside with the same stone as used on the north main entry portico. The painted wood louvers of the belfry are positioned directly above the windows of the floor below,

presenting a simple and pleasing composition. Loudspeakers that project the sound of bells have been hung from the ceiling, directed outward through the louvers.

The ceiling of the belfry consists of several exposed wood trusses running north-south which support the north and south portions of the hipped Belfry roof as well as additional roof members coming in from the east and west that support the east and west hips. This roof does not have any long spans, but is nevertheless relatively delicate. The steel support structure for a bell would only work for a relatively small bell.

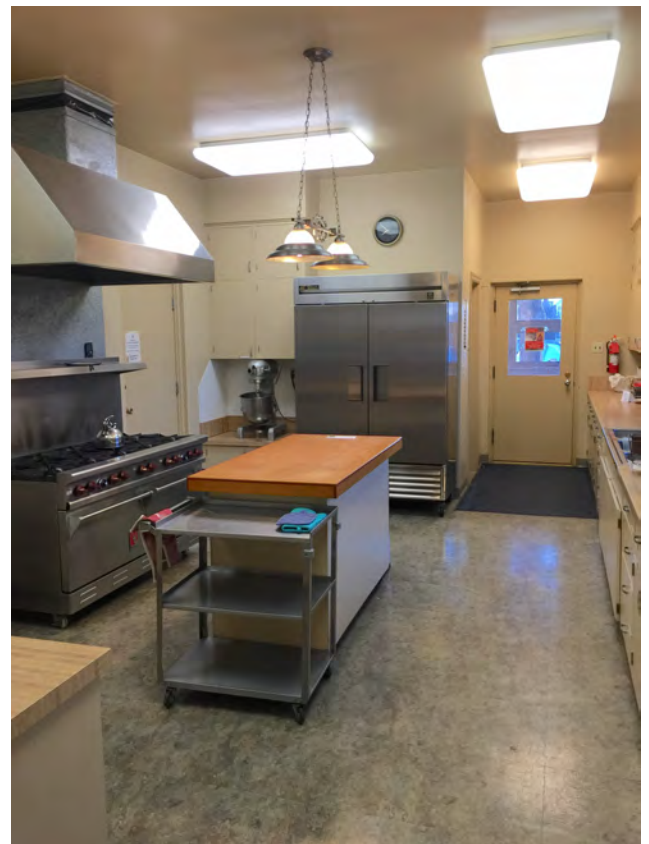
The kitchen size and layout make it difficult to fully convert it to use by a person in a wheelchair, although it might be possible to eliminate some under-counter cabinetry to create a dedicated wheelchair accessible workspace in some location on the south or west sides of the space.

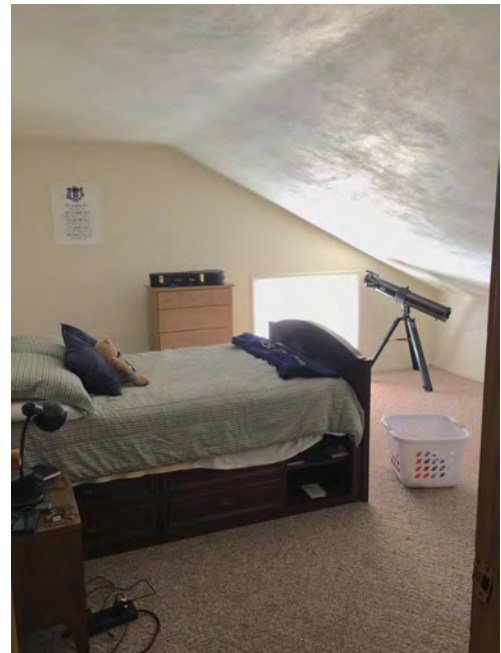
On the second floor, above the Library and a portion of the Fireplace Room, is an apartment with two rooms used as bedrooms, but neither is up to safety standards for exiting,

or in fact for even calling them bedrooms. The larger of the two rooms could be upgraded by enlarging and repositioning the existing window, but the smaller is wholly inadequate due to the lack of headroom and any window at all. Fortunately, the smaller room does not appear to normally be used.

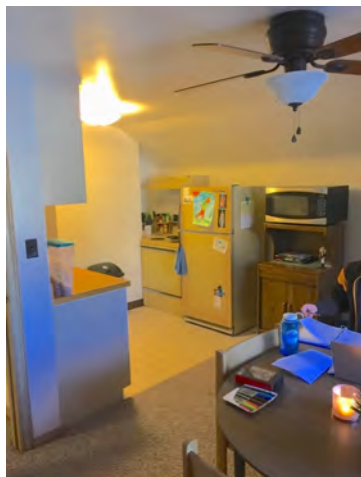
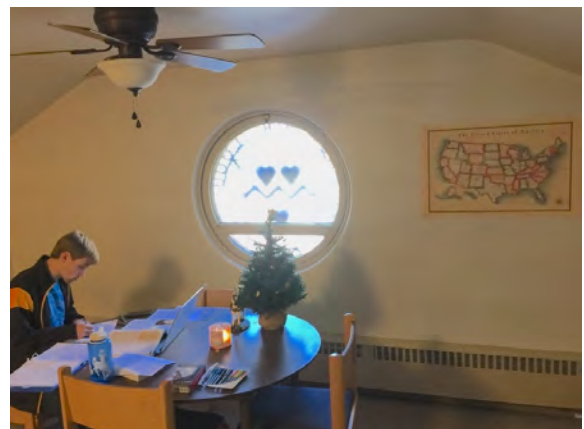
The small bathroom appears adequate for its intended uses, and the kitchen and dining/ study area on the north end of the apartment are adequate as well. As with all other spaces in the building, the apartment relies on operable windows for cooling, light, and ventilation, but as is visible from two of these photos, the operable portions of these windows are too small to be effective.

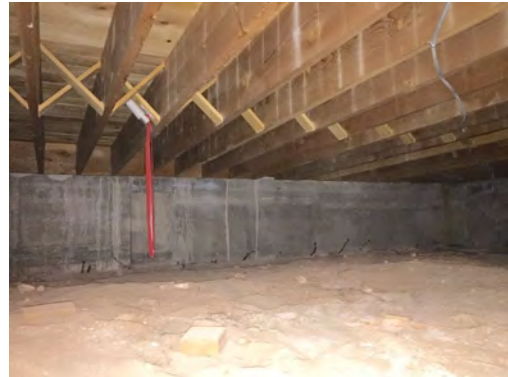
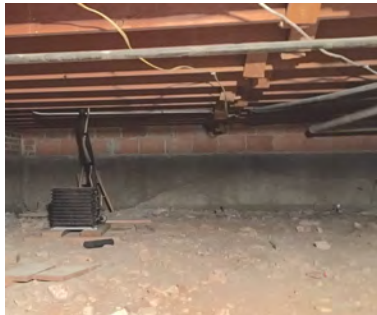
The crawlspace is in excellent condition. The dirt floor consists of fine powdery dirt and sand of a reddish color, very dry in all areas where inspection was made. There is no evidence of recent water intrusion, and only one area on the north wall below the NW corner of the Meeting Hall where there is evidence of efflorescence in the brick and associated staining from water that was likely introduced from the outside, perhaps by sprinklers or roof downspouts.

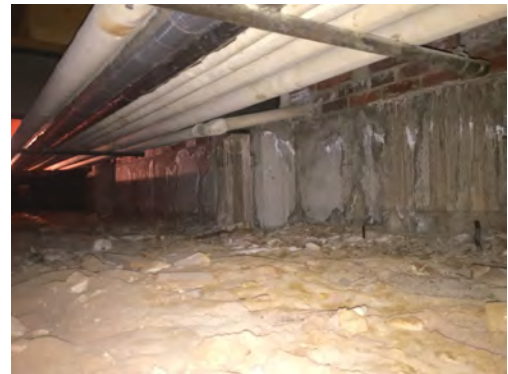
Besides the use of the crawlspace as the basis for the floor/ foundation system and space to run piping, the crawlspace at the southeast end of the building houses a small

condenser unit for the walk-in cooler which was relocated a few years ago to attenuate its noise from its previous location in the kitchen. The heat generated by the unit is minimal, but an asset in warming the crawlspace in the winter and is not so great as to cause undue warming of the crawlspace or the unit in the summer.

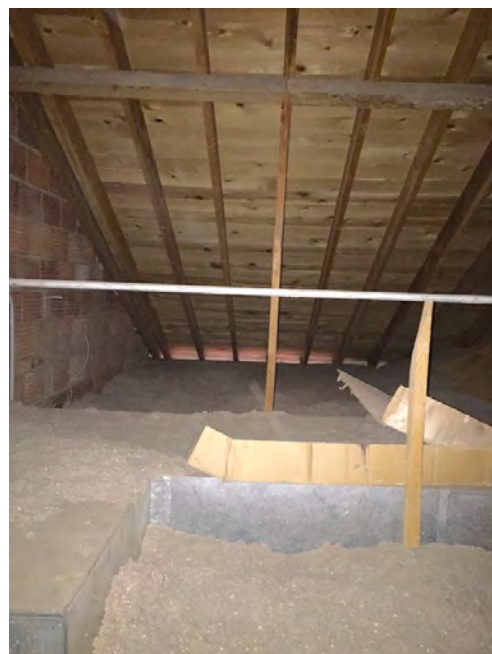
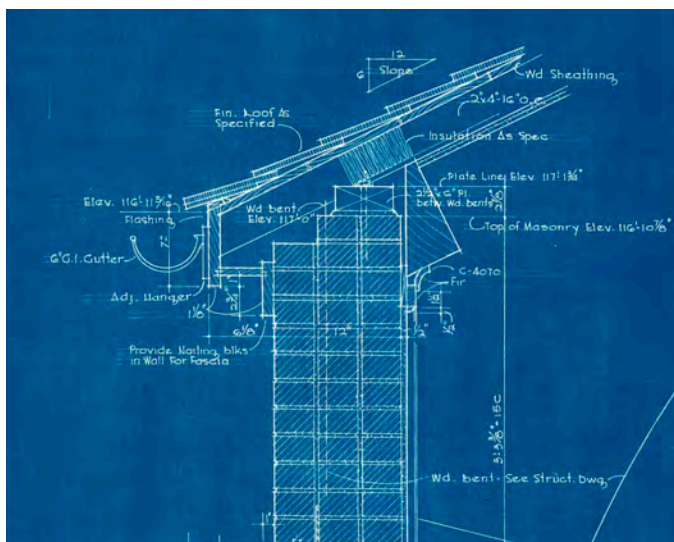
Except for the roof over the Nave (which has no attic), roofs are uninsulated, which is acceptable because the attic floors (top of the ceilings below) were originally somewhat insulated. It was not common for attics to be insulated in the 1950's, so this was an upgrade to common construction. In the years since, the attic floors have had about 9" of blown-in insulation installed. The additional insulation is important to reducing heat loss in the building, but because the attic has free flow of air from the outside, and in the case of the attic above Bishop Newell Hall, the ceiling along the north and south sides are quite sloped, the insulation blows around creating areas of greater and lesser insulation thickness, and therefore greater and lesser areas of heat loss. The insulation material is likely blown-in cellulose with an R-value of about R3.7 per inch, which at 9" comes to about R33.3.

The roof of the nave was specifically constructed so as to have some space for insulation; consequently, it appears from the original blueprints by Architect John K. Monroe, that there is a 3 ½" layer of insulation in place. Because there is no ready access to view the insulation, one guess as to its composition is that it could be Balsam Wood batts with an R-value of perhaps R 2.75 per inch, for a possible total value of R 9.6. If true, this would be considered high insulation value for a 1950s building, but still three or four times less than desirable by today's standards and expectations of energy conservation.

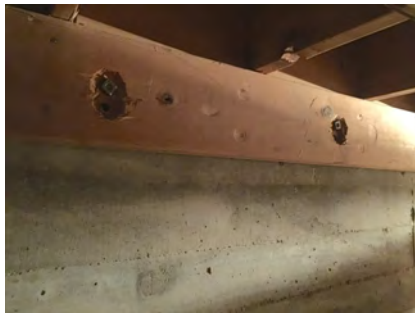
The ledger at the corridor connecting the Nave and Bishop Newell Hall appears to have limited fasteners to the foundation wall. The fasteners are performing well under existing loads, but they may not have the capacity for current code requirements if usage or live loads change.

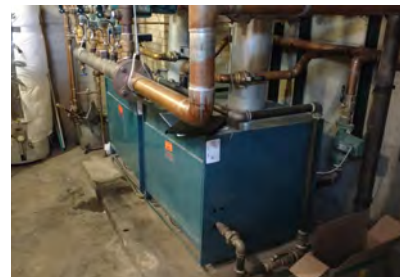
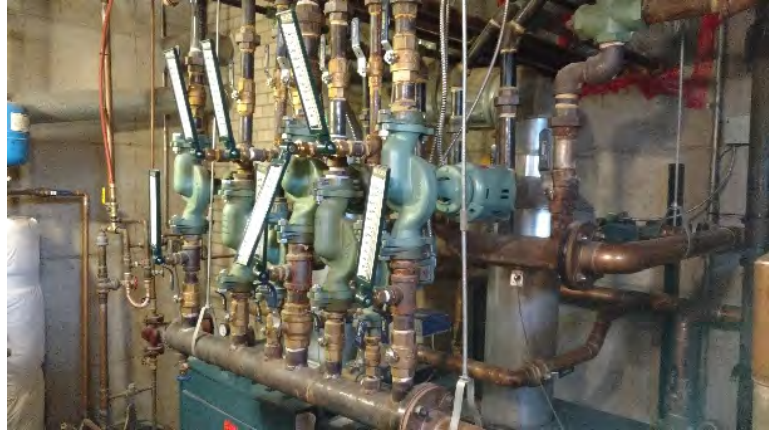
The building is heated throughout with hot water baseboard heat installed around the perimeter of the building. The heating hot water is provided by two atmospheric gas-fired cast iron boilers located in the basement boiler room. The boilers, boiler room piping, expansion tank, and zone pumps appear to have been replaced in 2008. The boiler piping in the boiler room is copper

and the piping from the boiler room to the baseboard heaters appears to be black steel schedule piping. The piping in the crawl space and the baseboard heaters appear to be original to the building. The two Burnham model #8H Boilers now in use were replaced in 2008.

pipng, baseboard heaters, exhaust fans, ductwork, controls etc. appear to be original to the building and are well past their normal expected life, with the exception of the cast iron boilers which were replaced in 2008. The boilers should reasonably be expected to have another 20 years of life if properly maintained. However, the boilers are rated at 80% efficiency and do not have modulating controls. New boilers are rated at least to 87% efficiency and if designed to be used in a low water temperature water system (< 135° F), can achieve efficiencies in the mid-90s. New boilers also have better modulating controls that allow them to turn down at least to a ratio of 5:1 which provides better temperature control and reduces boiler cycling.

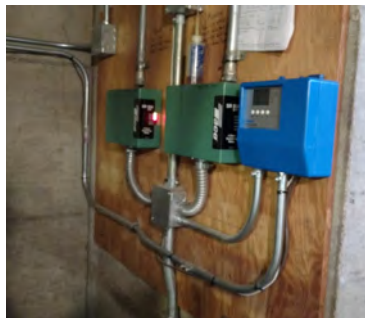
The boilers are equipped with seven zone pumps each piped to different areas/zones in the building through the crawl space. From the crawl space the pipes turn up through the floor with supply and return to the perimeter baseboard heaters. It appears that each zone pump is controlled by a space heating thermostat which will automatically start the pump to flow water through that Zone's baseboard heaters when the temperature drops below the heating set point.

Heating Water System Zone Pumps: 2 Taco Zone Pump Controllers & 1 Tekmar Boiler Controller.

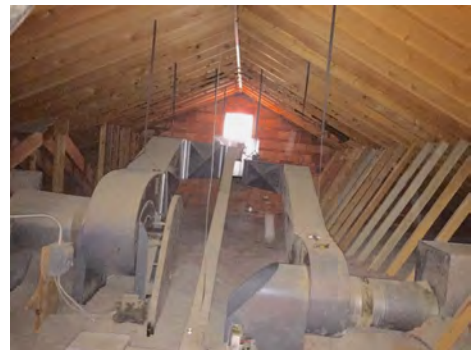
The Nave and Bishop Newell Hall have large exhaust fans located in the attic which can manually be turned on in the summer to bring in fresh outside air through the building operable windows and then exhaust the air back out. This was a common design scheme in churches to provide

cooling/ventilation in the summer. The drawback is that the building has no fresh air ventilation during the winter when the operable windows are closed. In addition, the air that is brought in during the summer is not filtered.

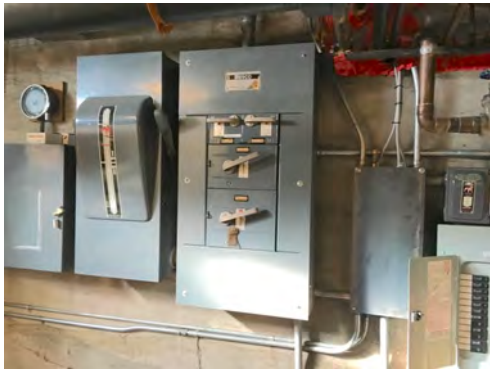
The existing electrical service is a 120/240-volt, 1-phase, 400-amp, overhead-feed from the south side of the alley. The conductors enter a weather head, then into conduit traveling down the outside of the building, where they enter the basement electrical room. Original plans suggest 3 # 350 in 3" conduit. There are Current Transformers (CTs) at the weather head. The metering wiring from the CTs enters another weather head, then into conduit, to a meter on the outside of the building.

Except for Panel P-1 and Panel F, the service and distribution panels are dated, and should be replaced. The service to the building should be upgraded to a 3-phase service if air conditioning is ever considered for the building.

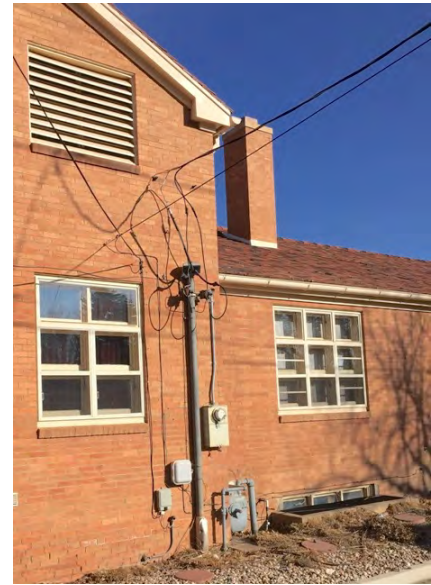
The electrical service equipment in the basement consists of a former CT can; main 400-amp 120/240-

volt, fused disconnect; a distribution panel (MDP) with fused switches; former Panel A, used as a splice box; and a newer breaker panelboard labeled "P-1." The MDP has the following switches: 60-amp for Panel P-1, 60-amp

for the kitchen Panel C, 100-amp for the sacristy Panel D, 200-amp for Panel B.

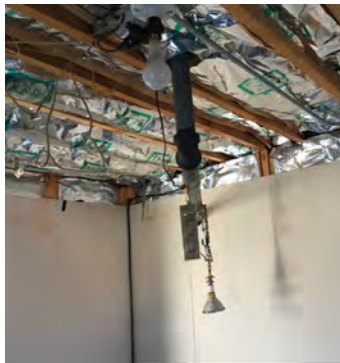
Other than the lights in the nave and the nave spillover space, as well as the pendant lights in the kitchen, there is not any special lighting that would be of any value for a remodel. Most of the lighting is fluorescent and incandescent, with a few fixtures that have LED lamp replacements such as in BNH. The lighting level is adequate throughout the church.

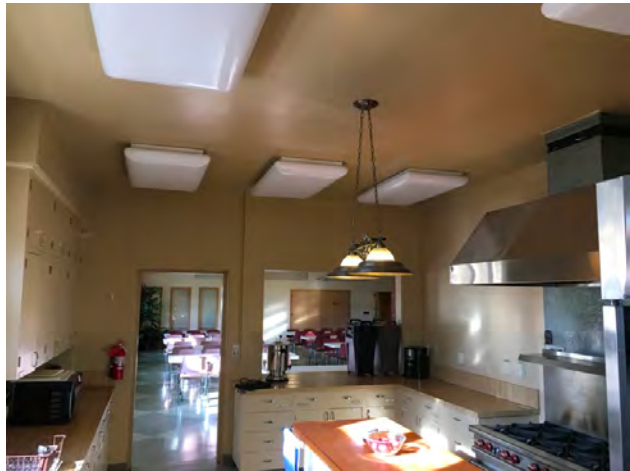
code egress requirements. There are a few exceptions at some of the secondary doors. Lighting controls are standard snap switches, and there are no dimming controls. The lighting and controls do not meet the current energy code standards. Most of the wiring to the lighting is code compliant, although there are a few exceptions.

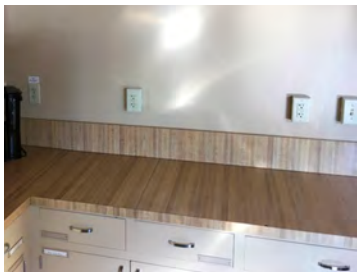
As far as can be determined, the power wiring in the building is code compliant with a grounded system, including grounded-type receptacles. All exposed circuits that could be observed were either in a conduit system or wiremold raceway. There are a few areas where the conduit is not properly supported. As in most older buildings, there is the need for more receptacle locations. There has been some tripping of breakers. This suggests there are not enough circuits available for occupant use in the building. The kitchen area had been upgraded with additional receptacles wired to Panel F.

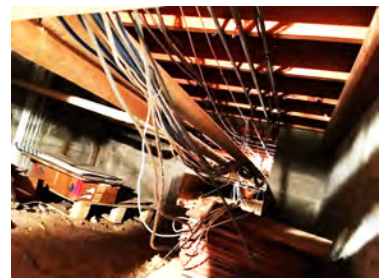
The telephone and cable service is located overhead from the south side of the alley, running down the outside wall, and then entering the basement. The telephone and cable punch-down locations are in the crawl space, north of the basement boiler and electrical rooms; however, this location is not very convenient for access to the service location. The original building had telephone runs only; however, over the years, additional cables for telephone, data and cable have been added throughout the building. There are locations where cables have been abandoned but not removed;

there is now a system of cables with unidentified origins or endings. The cables have been run to locations via the crawl space, and they are not supported correctly. The church is currently having issues with their telephone system. It is not known if the problem is the telephone system or the cabling.

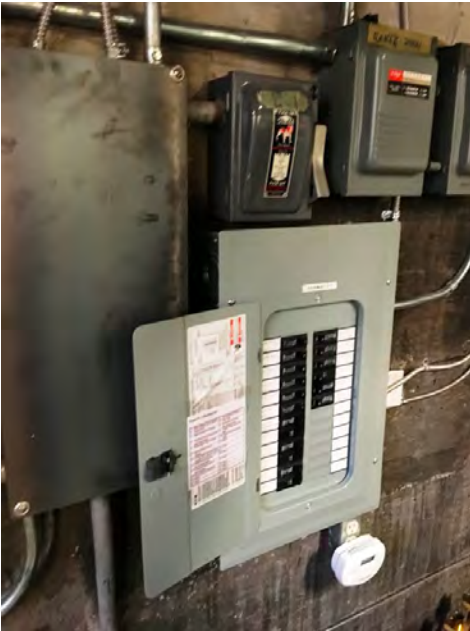
Panel P-1: Eaton, 24-space, push-button breaker panel

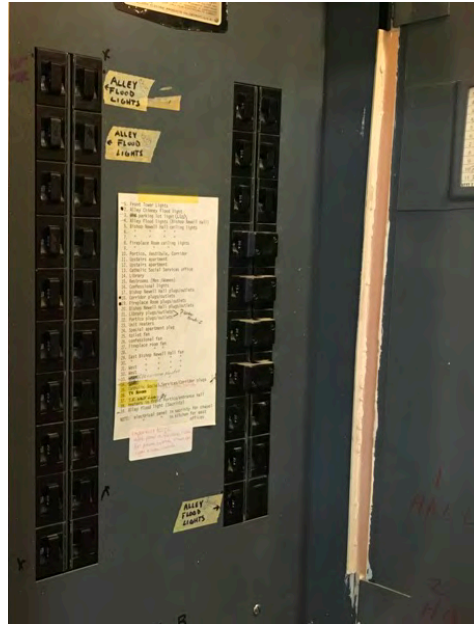
Panel B: 40-space, push-button 100-amp breaker panel

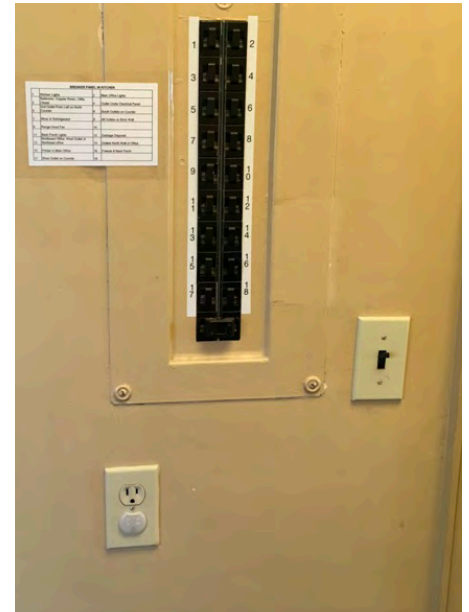
Panel C: 18-space, push-button breaker panel

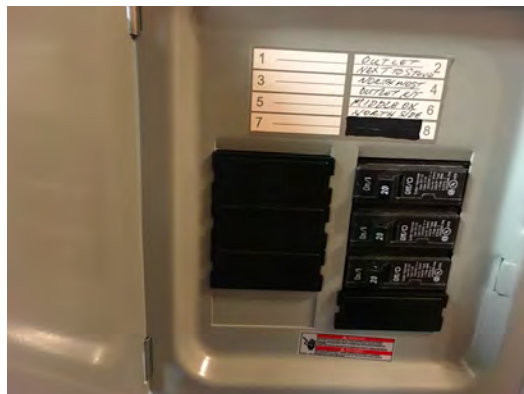
Panel D: 20-space, push-button breaker panel
